Xbox 360 Top Vent Replacement

Top vent replacement.

Use this guide to remove the gray plastic top vent from your Xbox 360.

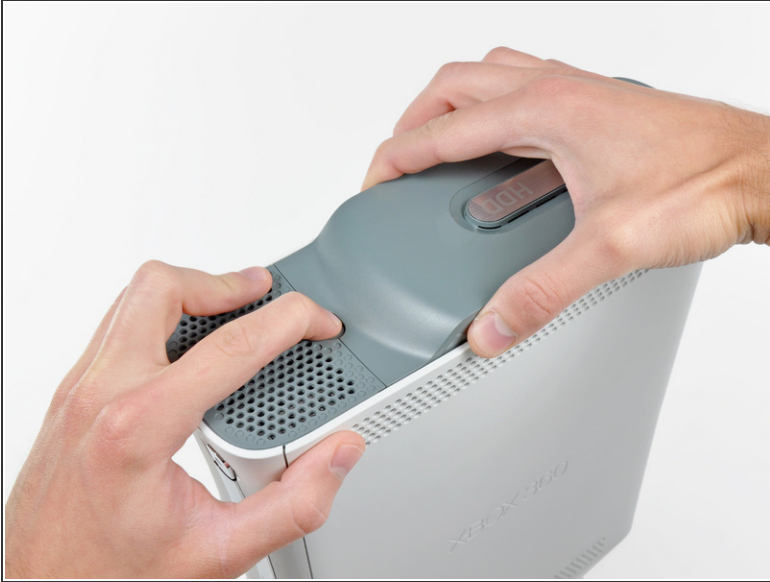
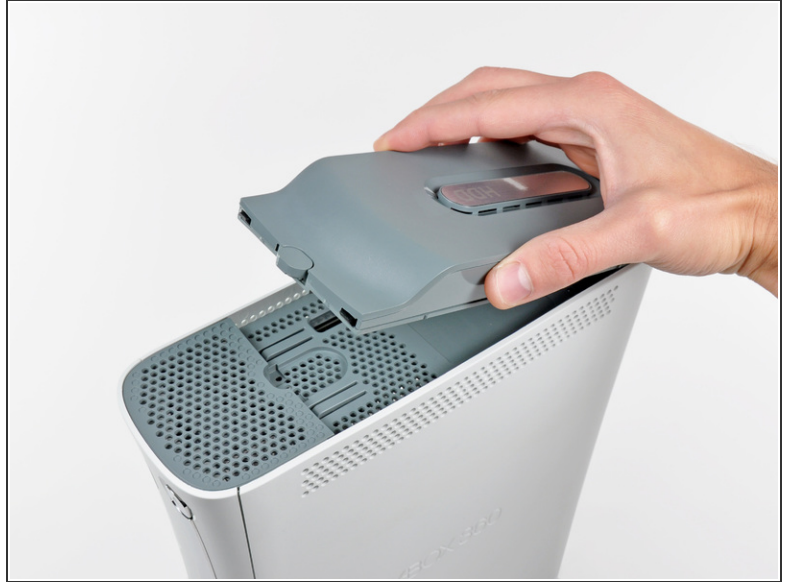
Step 1 — Hard Drive

- Grasp the hard drive assembly and press the release button while lifting its front edge.
- Remove the hard drive assembly from the top vent.

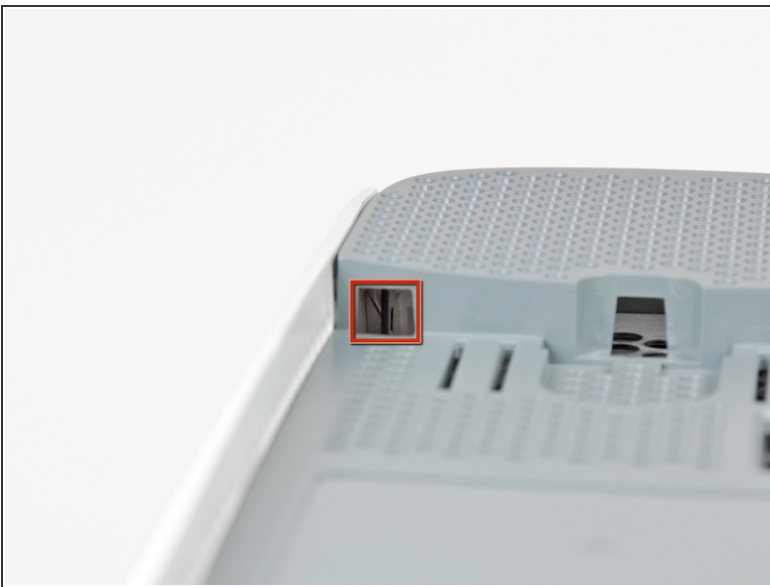
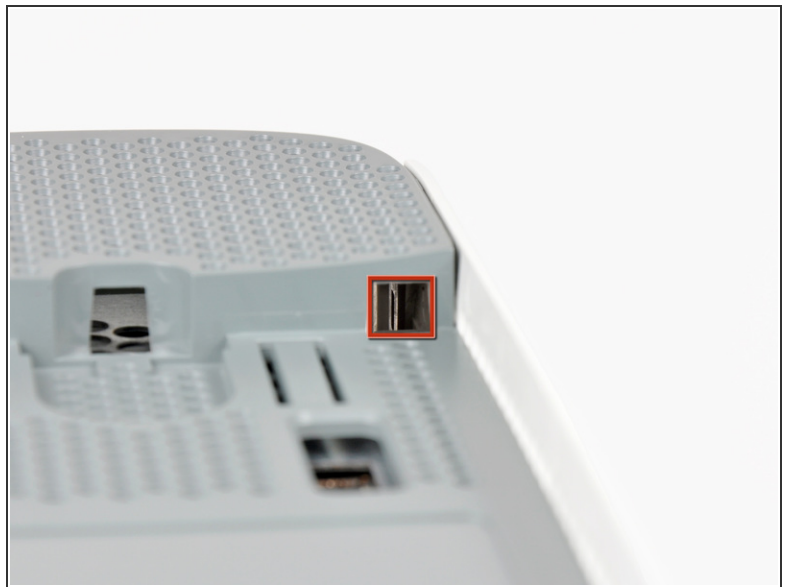
Step 2 — Top Vent

- ★ Stand the console vertically with the top edge facing up.
- The top vent is secured to the console via clips. The first two clips are located underneath the top vent closest to the faceplate, as shown in the pictures.

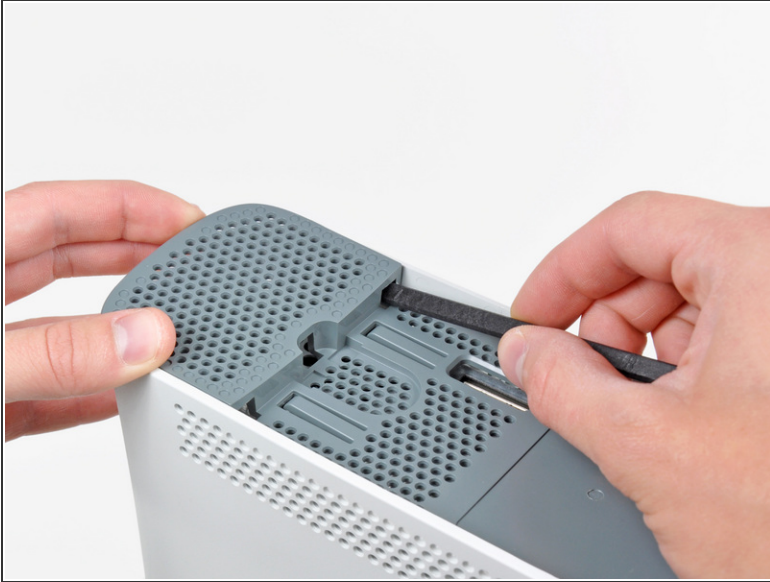
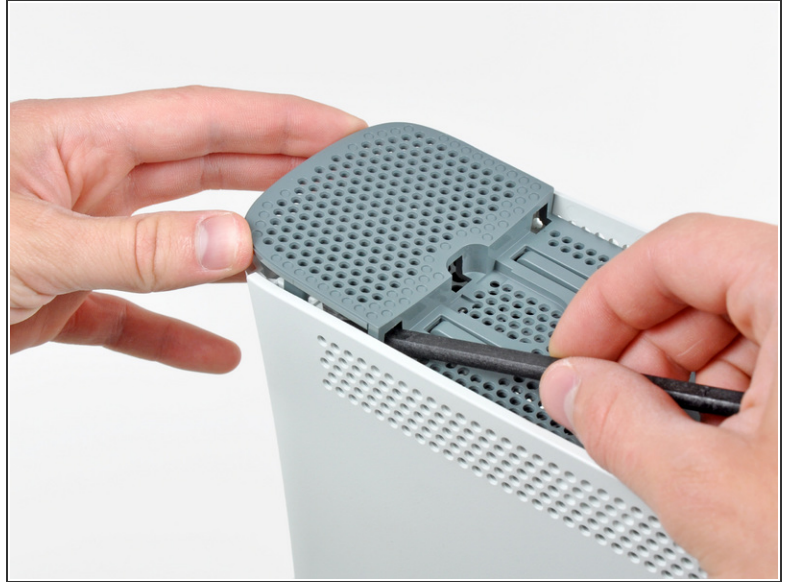
Step 3

- Insert the flat end of a spudger into the small gaps previously mentioned to release the clips.

i You may also use the long finger of an Xbox 360 opening tool to accomplish this task.

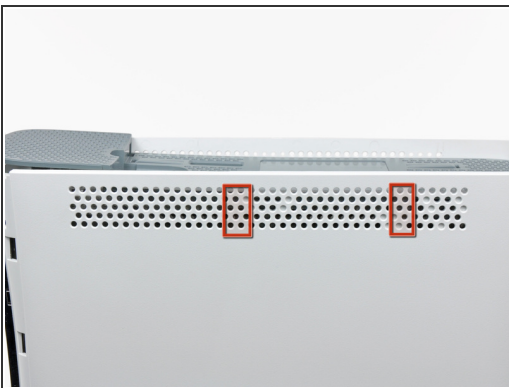
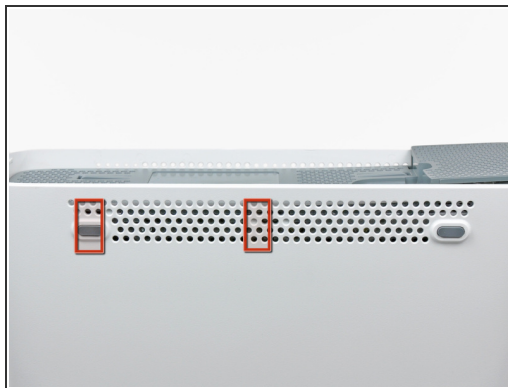
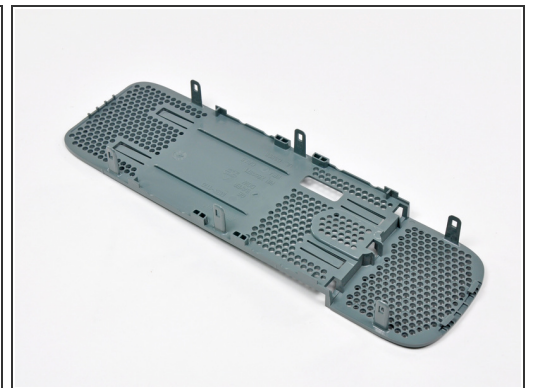
Step 4

i In the next few steps, you will use the tip of a spudger or the finger of an Xbox 360 opening tool to release the clips along the left and right sides of the top vent. Their locations are highlighted in red.

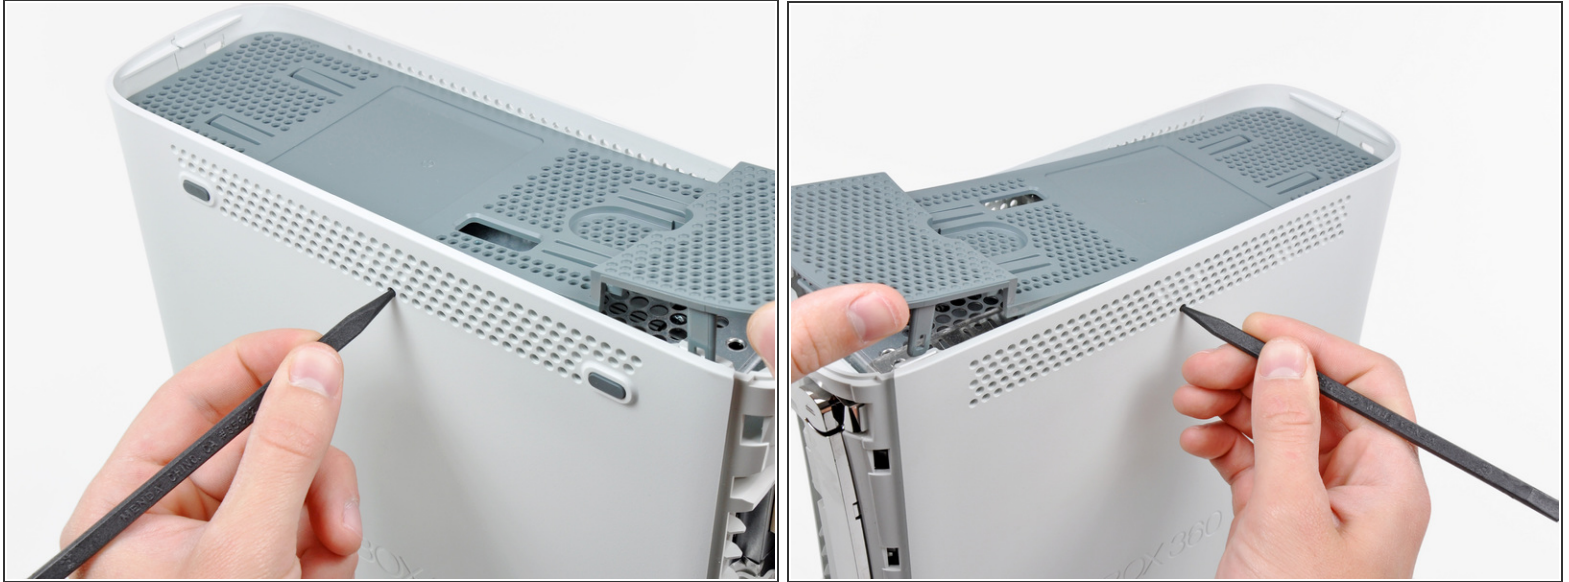
Step 5

- To release the clips, work from the middle of the top vent.
- While slightly lifting the front edge of the top vent, use the tip of a spudger to push the clips closest to the center of the top vent towards the inside of the console.

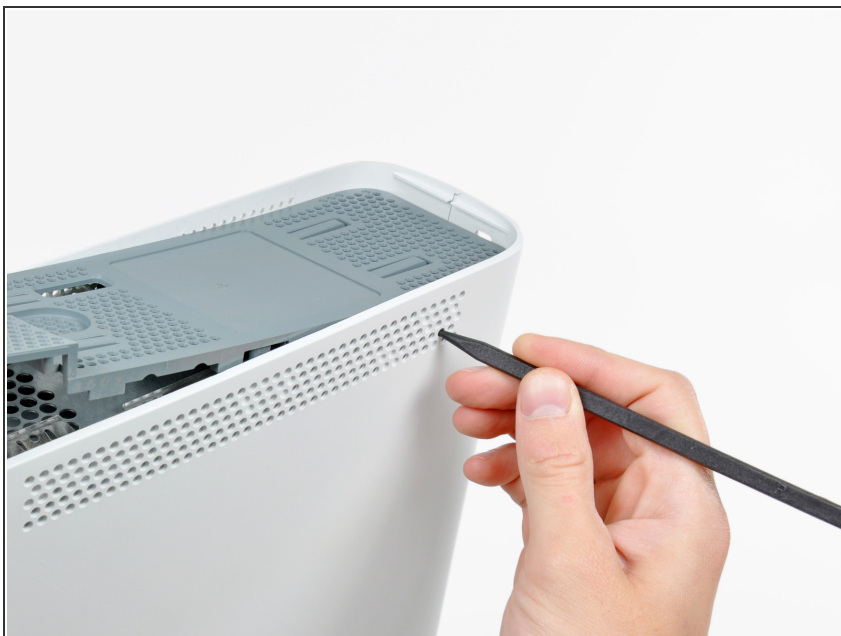
Step 6

- Use the tip of your spudger to release the clip on the top vent nearest the back of the Xbox's upper case.

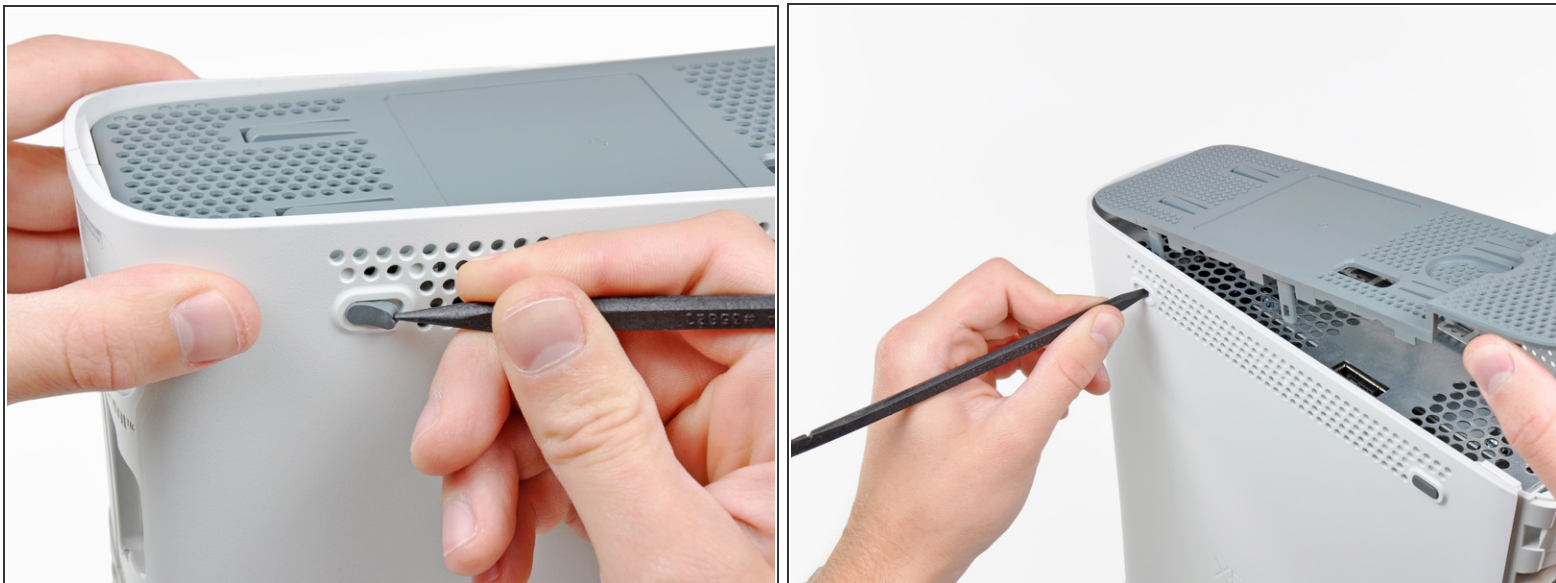
Step 7

- i** The last clip is hidden underneath the rubber foot nearest the back of the console.
- Use the tip of your spudger to release the clip on the top vent nearest the back of the Xbox.
 - Remove the top vent from the 360.
